Newington Town Hall
Renovation Feasibility Study
Newington, CT

April 20, 2016

Feasibility Study

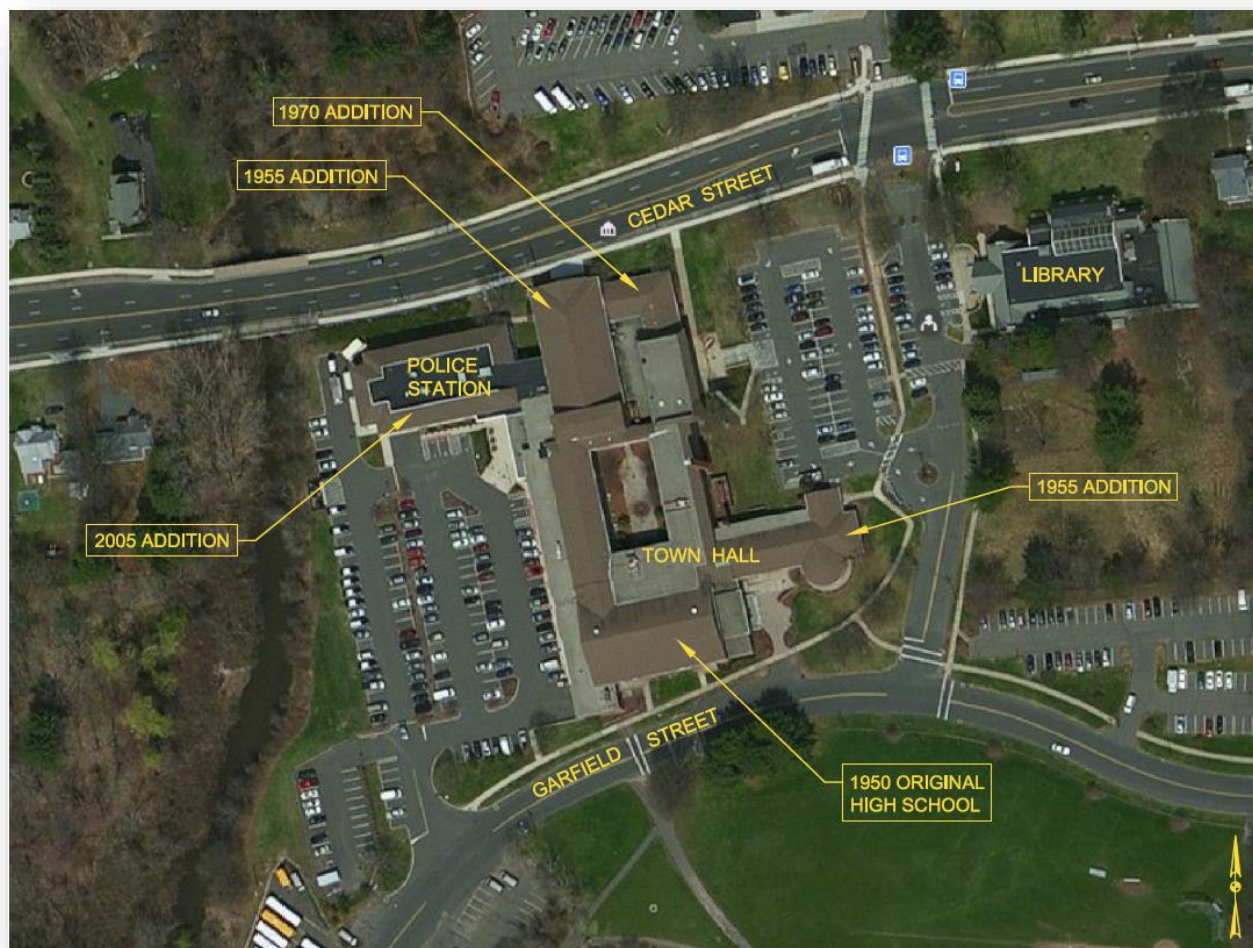
Directional signage guiding visitors to Town Hall is limited, as the official address is still Cedar Street. Individuals that are not familiar with the area may find it confusing. Access for handicapped individuals is good on the west side of the site. The parking drainage system is comprised of a network of catch basins within the roadways, parking area, and a few yard drains in landscaped area. The outfall is to the river. Generally the system functions adequately. (See the following overall site plan).
